Tree Assessment & Preservation Plan
Glen Canyon Park

Prepared for:
Recreation & Park Department
City of San Francisco
30 Van Ness Avenue
San Francisco CA 94102

Prepared by:
HortScience, Inc.
325 Ray Street
Pleasanton, CA 94566

October, 2012

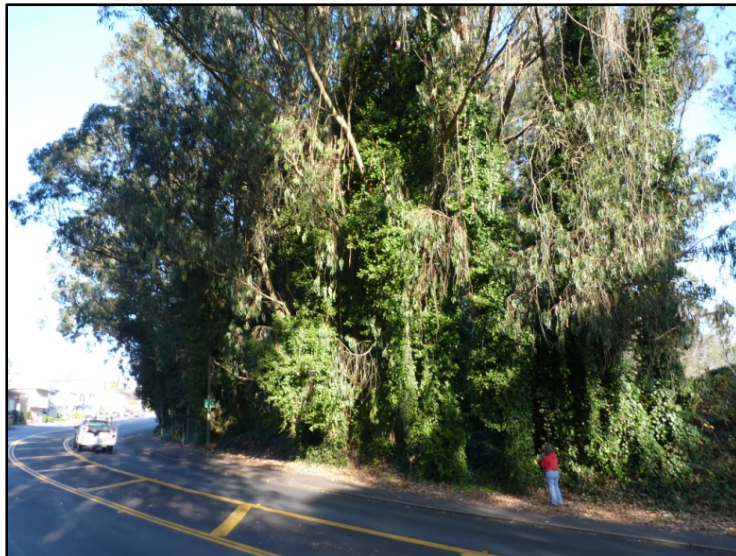
Photo 1. Blue gums #600 to 623 were part of a dense planting along O'Shaughnessy Blvd. Note extensive growth of vines along the trunks.

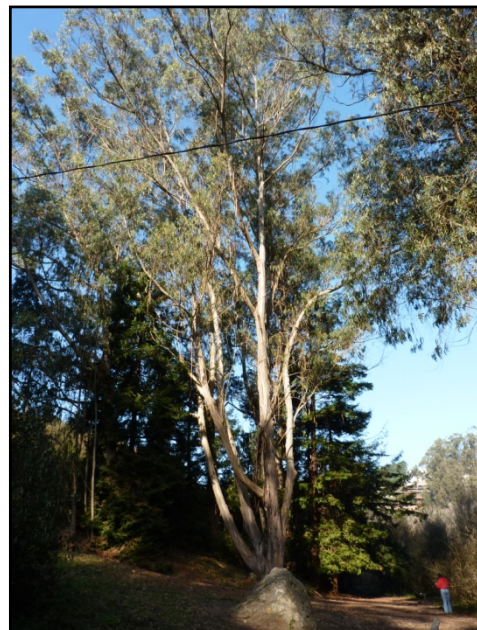
Photo 2. Located in the center of the park, near the pre-school facility, blue gum #625 was 90" in diameter and in fair condition.

617	O'Shaughnessy	E.	Blue gum	25	2	9	Remove tree	Risk rating ≥9
619	O'Shaughnessy	E.	Blue gum	32,28,12,10	2	8	Remove tree	Poor condition
625	Glen Park	Trail	Blue gum	90	3	7	Noted in Trail project report as prune to clean crown & reduce long laterals.	
627	Glen Park	Trail	Blue gum	29,28,25	3	9	Prune to remove 25" stem	Risk rating ≥9

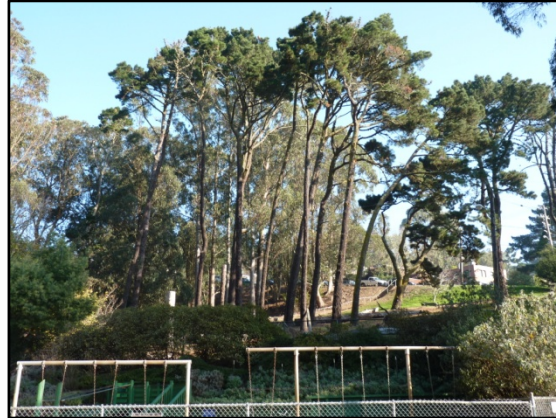
Photo 3. Pines #41 – 57 were generally in poor condition with small high crowns and leaning trunks.
